# Cluff Lake Decommissioning: Is it complete?

## One man's questions, the company view and what the regulators say

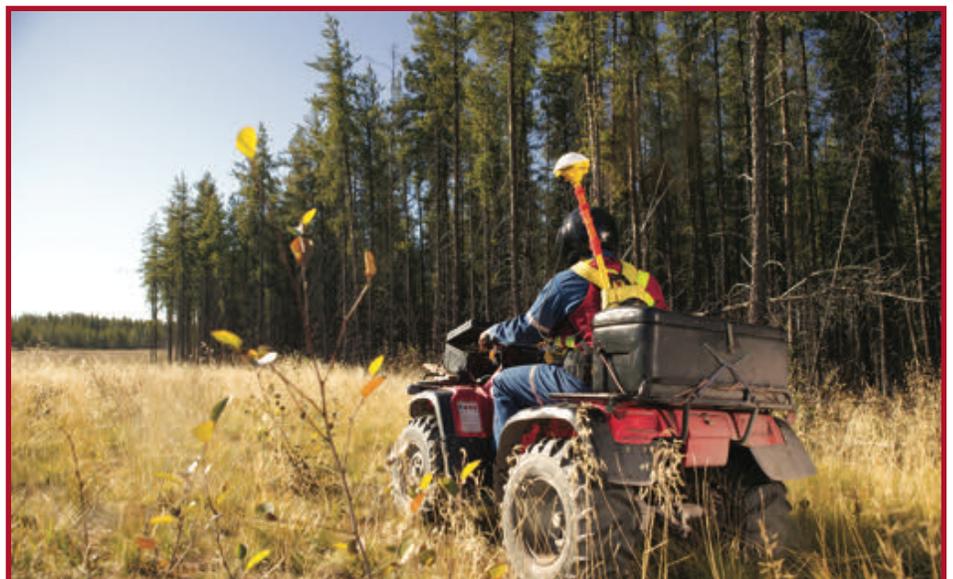
**A gamma radiation survey was done on the whole site to make sure everything was safe. File photo**

Some areas that had subsided received additional material in 2013, and the cover is effectively isolating the tailings material from the environment. No tailings have been observed at the tailings area. Gamma radiation surveys show near background levels; any exposed tailings would emit 20-30 mSv per hour.

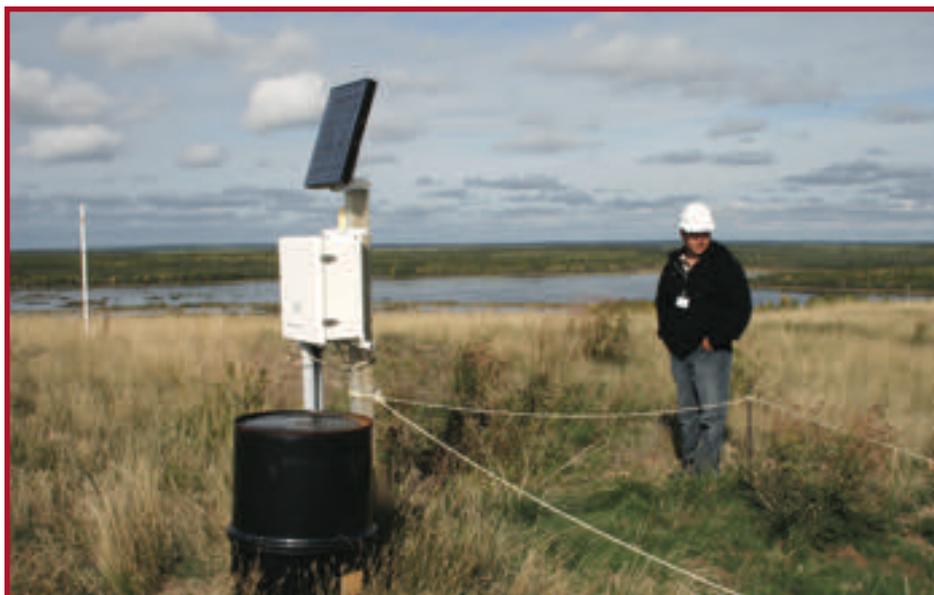
**A community member checks the vegetation on top of the Claude waste rock pile in 2008. Vegetation was already growing well on the clean cover. Claude Lake is in the background. File photo**

The pile was decommissioned knowing it contained special waste or low-grade ore. The surface was compacted, covered with clean till cover and revegetated to limit water infiltration. The cover is sufficient to limit rain and snow from penetrating the pile, therefore leaching of waste rock has been minimized.

**The CNSC says:** The Claude pit was filled with waste rock and covered with clean till when decommissioned. CNSC staff inspect the Claude waste rock pile to ensure the cover is performing as designed. Run-off water over the cover does not contact the waste rock and is therefore safe to consume by animals and birds.
